**From:** Montera, Jeff  
**Sent:** Wednesday, July 26, 2006 1:44 PM  
**To:** 'cohn.matthew@epamail.epa.gov'; Churchill.Peggy@epamail.epa.gov;  
'Atencio.Kathie@epamail.epa.gov'  
**Subject:** Libby Completion Folders  
**Attachments:** Bowers.zip; Ranaldi.zip

### **Bowers Response Action Work Plan Addendum 33 Glendora Avenue**

# **Addendum to the Response Action Work Plan Bowers Residential Removal Plan 33 Glendora Avenue**

# **Removal and Restoration Completion Form for Response Action at**

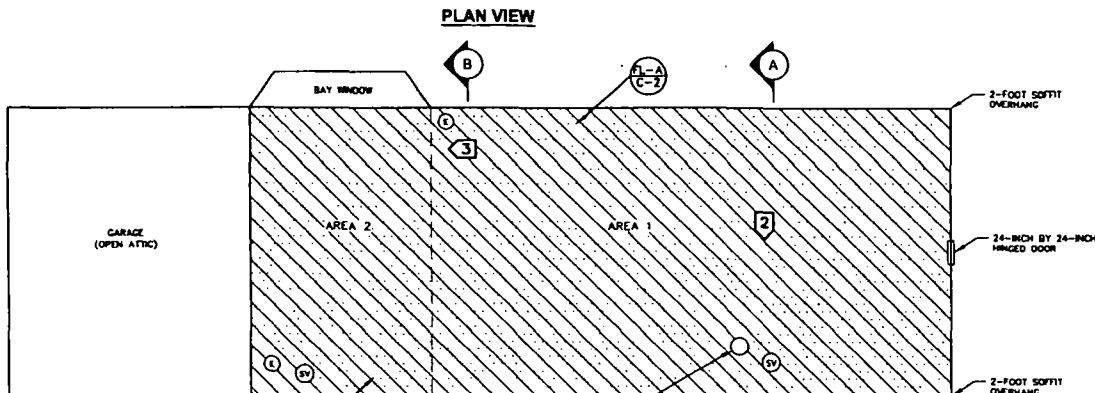
1 NORTH EXTERIOR OF HOUSE AND ATTIC ACCESS

- The house has an unfinished attic (Areas 1 and 2) with an addition on the east side. Areas 1 and 2 are accessed by a 24-inch by 24-inch hinged door on the north exterior wall of the house. The addition on the east side is not accessible from the main attic, contains no visible vermiculite insulation, and has a separate airspace from the main attic.

1. ENSURE AN 18-INCH BY 18-INCH OR EQUIVALENT AREA IS MAINTAINED AT THE ATTIC ACCESS, FREE OF OBSTACLES, FOR THE INGRESS AND EGRESS OF PERSONNEL.
2. REMOVE, TRANSPORT, AND DISPOSE OF ALL INSULATION FROM THE ATTIC. THE ESTIMATED VOLUME OF INSULATION DOES NOT INCLUDE ANY VERMICULITE INSULATION THAT MAY BE REMOVED FROM THE GROUND FLOOR WALLS.
3. REMOVE A SUFFICIENT QUANTITY OF VERMICULITE INSULATION FROM EXTERIOR WALLS IN ORDER TO SEAL THE WALLS.
4. INSTALL BLOWN-IN INSULATION IN AREAS 1 AND 2, AND RESTORE ALL AFFECTED ATTIC AREAS. THE INSTALLED INSULATION WILL HAVE A MINIMUM RATING OF R-38.
5. INSPECT ALL SEAMS, CAPS, CONDUITS, AND ELECTRICAL FIXTURES ON THE GROUND AND BASEMENT FLOORS FOR VERMICULITE INSULATION. ANY AREAS CONTAINING VERMICULITE INSULATION WILL BE CLEANED AND SEALED.
6. PERFORM AN INTERIOR CLEANING OF THE BASEMENT.

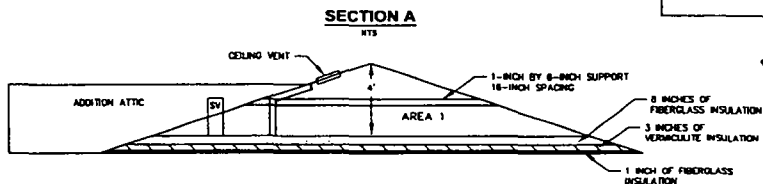
2 AREA 1 VENTS

- Areas 1 and 2 have no flooring above the joists and are both insulated with 1 inch of fiberglass batt insulation, overlain by 3 inches of vermiculite insulation, and an 8-inch layer of blown-in fiberglass insulation. Area 2 is delineated by the extensive support structures in the south section of the main attic, offering limited access.
